NATIONAL TRANSPORTATION SAFETY BOARD

MATERIALS LABORATORY FACTUAL REPORT

Report No. 00-134

Place : Juneau, Alaska
Date : June 6, 2000
Vehicle : Marine Vessel Columbia
NTSB No. : DCA00-M-M030
Investigator : Tom Roth-Roffy, MS-30

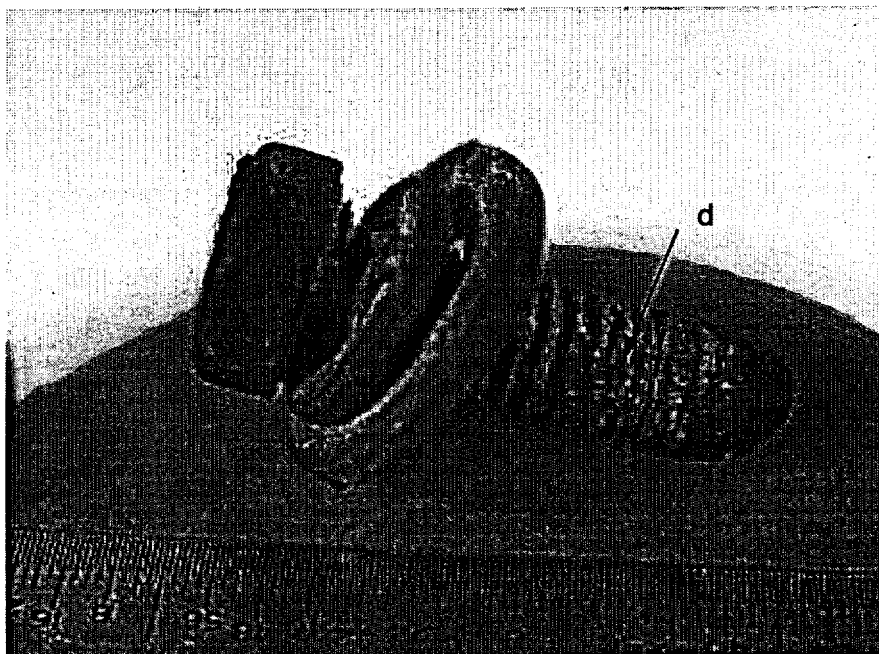
ImageNo:009A0164, Project No:A00064

As shown in figure 1, the subject bolt and washers generally appeared dark in color. Some orange-colored areas were observed in the threaded region of the bolt, on the inner surface of the larger (inner) washer, and around the edge of the inner washer. Beaded orange-colored and dark-colored material was observed on the head, on the outer surfaces of both washers, and in the threaded portion of the bolt. Material was observed filling the thread valleys in the bolt, and, within 0.02 to 0.03 inches of the threaded end of the bolt, the

threads were indiscernible. The thread peaks appeared deformed in one area, indicated by arrow "d" in figure 1.

Figure 1. Overall view of the subject bolt and washers. Arrow "d" indicates location of damaged threads.

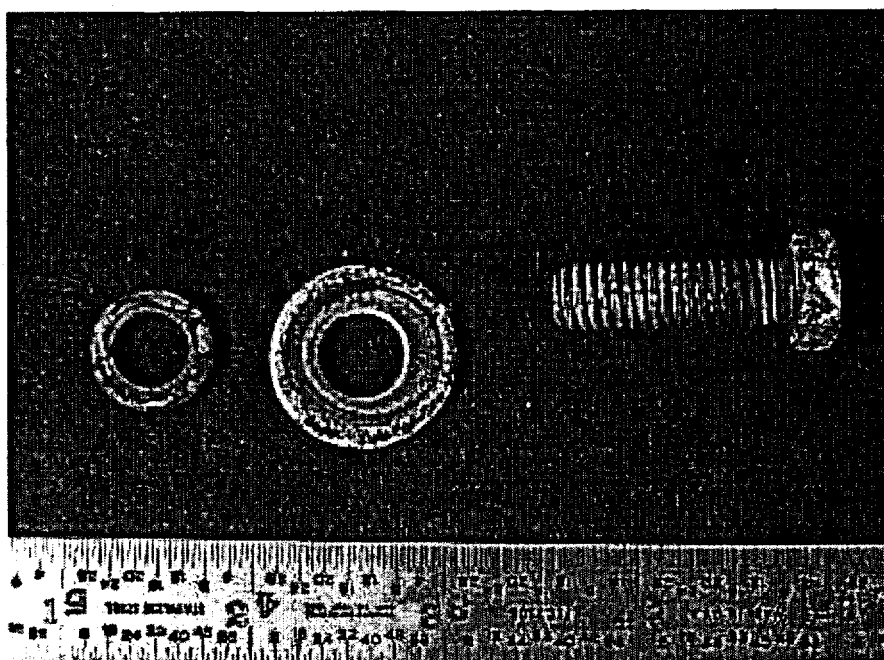
ImageNo: 009A0193, Project No:A00064

As shown in figure 2, the exemplar bolt and washers were generally lighter in color with fewer orange-colored areas. Beaded orange-colored material was present on the outer surface and edge of the larger washer and on the inner surface of the bolt head. Orange-colored material with a flattened appearance was present on the inner surface of the larger washer. The outer edge of the bolt head had a melted appearance around approximately one third of the head.

Figure 2. Overall view of the exemplar bolt and washers.

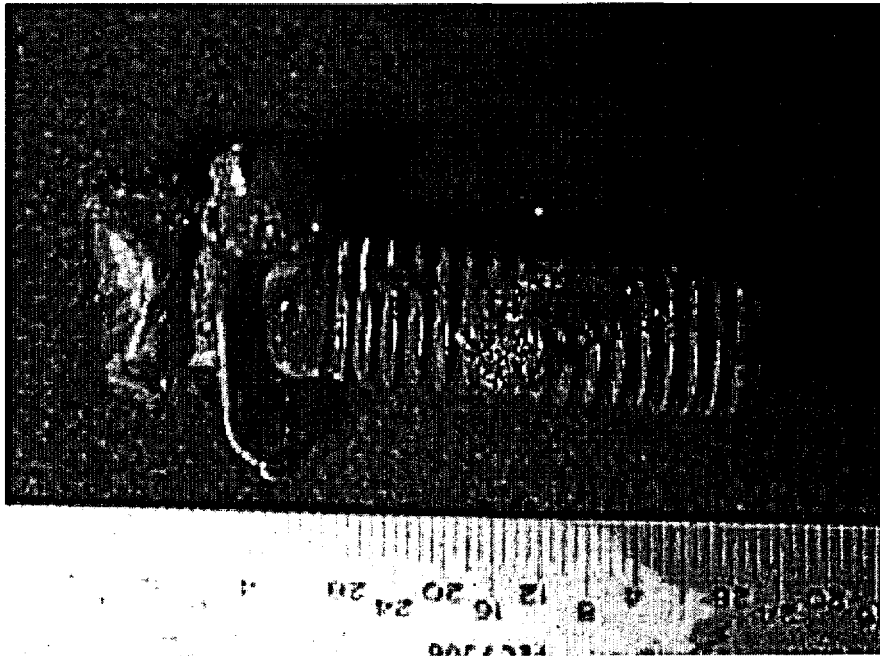
ImageNo:009A0198, Project No:A00064

The intentionally arced bolt and washer, shown in figure 3, appeared generally lighter in color than the subject bolt and washers. The head of the bolt appeared partially melted. Two relatively large beaded regions were observed, one in the threaded portion and one at the washer location. The beaded region in the threaded portion appeared porous. The beads appeared mainly dark with some orange color.

Figure 3. Overall view of the intentionally-arc'd bolt and washer.

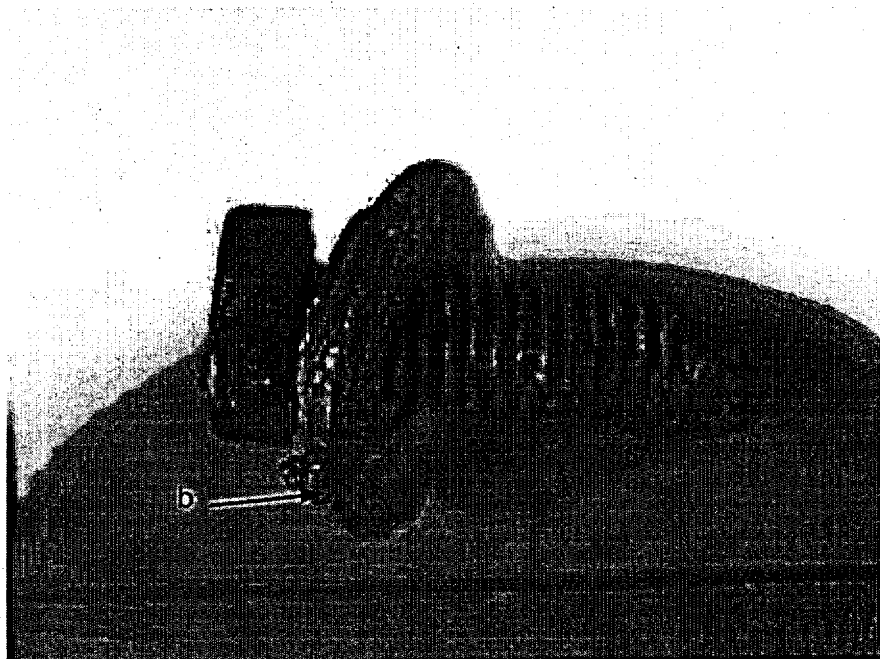
ImageNo: 009A0168, Project No:A00064

A relatively large, flattened bead, indicated by arrow "b" in figure 4, was observed on the edge of the inner washer. The bolt seemed to rest easily in a position with the flattened surface of the bead positioned downward. In that position, beads on the head of the bolt were aligned vertically. Also in that position, material that accumulated between the thread peaks was greater on the underside of the bolt, consistent with flow under gravitational forces.

Figure 4. Another view of the subject bolt and washer. Arrow "b" indicates relatively large bead with flattened surface.

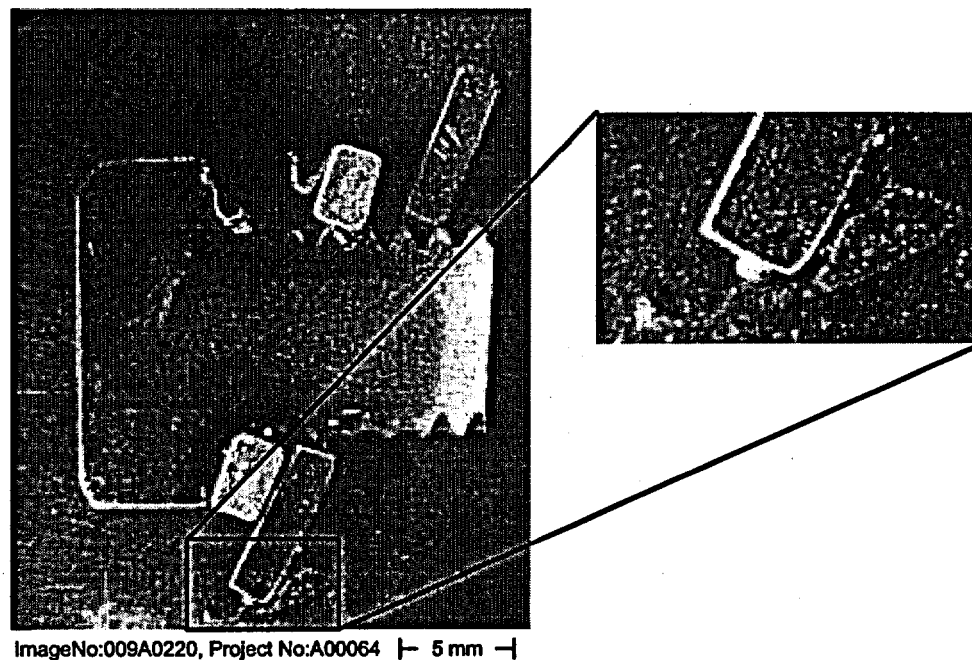
The cross-section of the head end of the subject bolt and washers is shown in figure 5. The flattened bead, "b", is highlighted in figure 5, and consisted of orange-colored material mixed with a dark-colored material, with the orange-colored material adjacent to the washer. The edge of the washer appears distinct and undeformed at that location. A layer of orange material was also observed between the washers and the bolt shaft, as shown in figure 7 at higher magnification. The dark circular area in the orange region in figure 7 is a void.

Figure 5. Cross-section of the head portion of the subject bolt. Highlighted region shows the flattened bead at the edge of the washer.

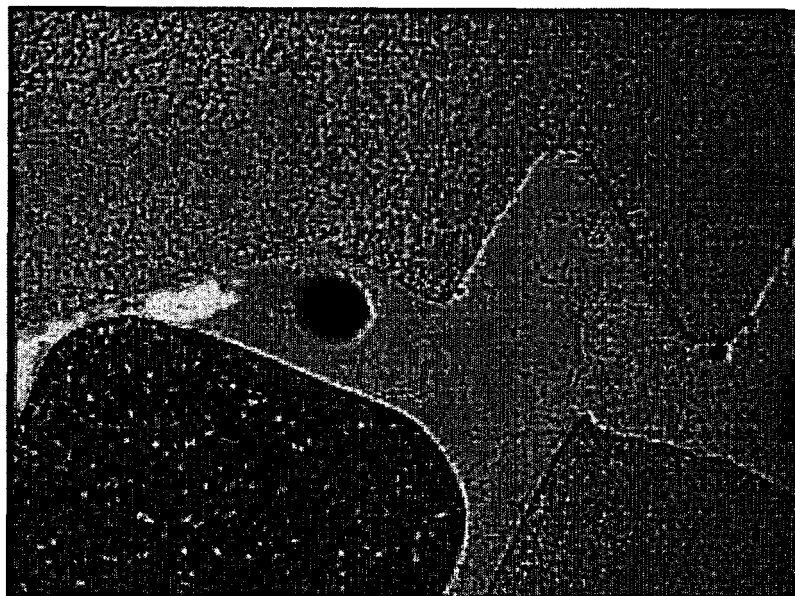
ImageNo: 009A0201, Project No:A00064

Figure 7. Higher-magnification view of the region between the washers and the shaft in the subject bolt cross-section. The bolt is shown at the top and the washers at the bottom left (outer washer) and right (inner washer). Orange-colored copper fills the region between, with a void appearing as a dark circle in the copper.

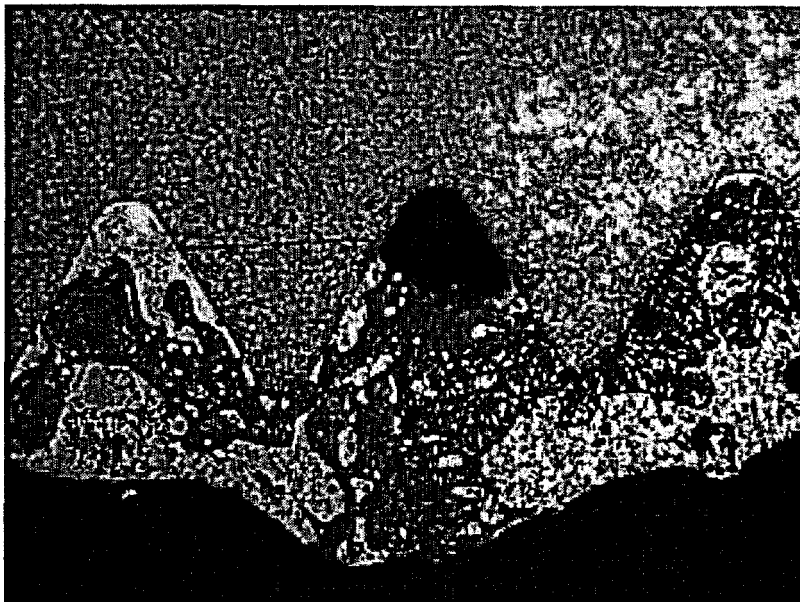
ImageNo:009A0213, Project No:A00064

Figure 8. Higher magnification view of the material at location "t" from figure 6. The bolt is at the top, and the accumulated material is a mix of copper (orange color) and iron (dark color) phases. A void is present in the middle thread valley.

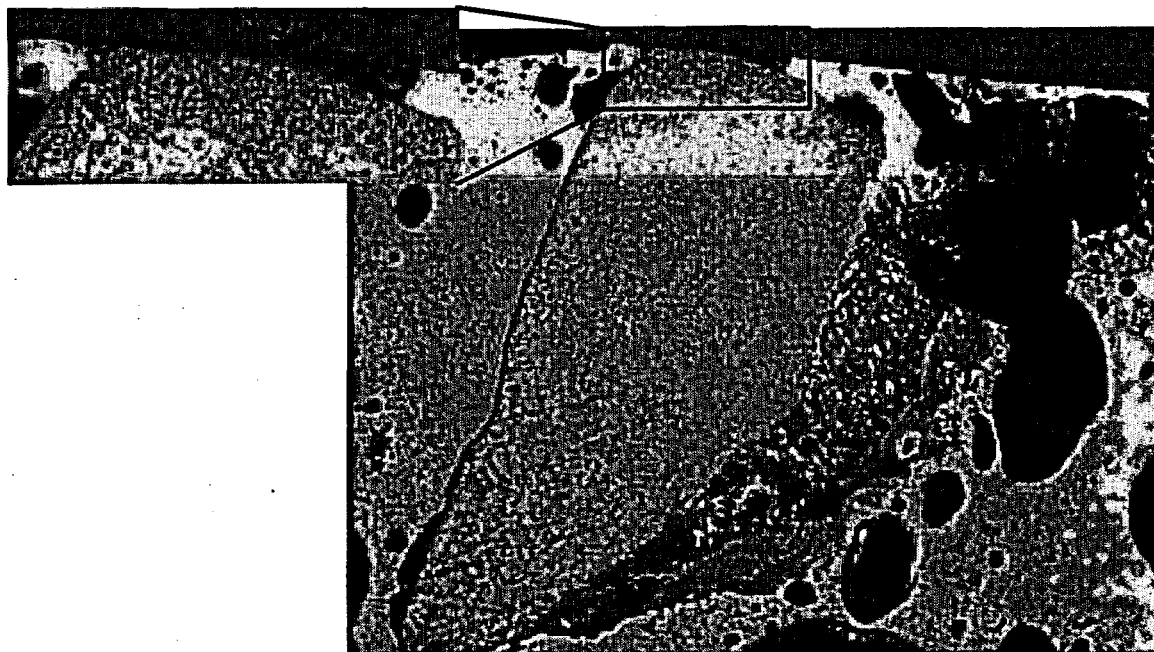
ImageNo:009A0240, Project No:A00064

A view of the cross-section of the beaded region at the washer location is shown in figure 9. The edge of the washer is missing and appears to have melted into the dark colored phase in the mainly orange-colored bead. A contact region between the washer and bolt was observed, as shown highlighted in figure 9, with no orange-colored material observed between the washer and bolt. Numerous large voids were observed in the orange-colored phase of the beaded material.

Figure 9. Cross-section of the intentionally-arc'd bolt and washer with a highlighted area showing contact between the bolt shaft (above) and washer (below). Orange-colored copper is present on either side of the contact area.

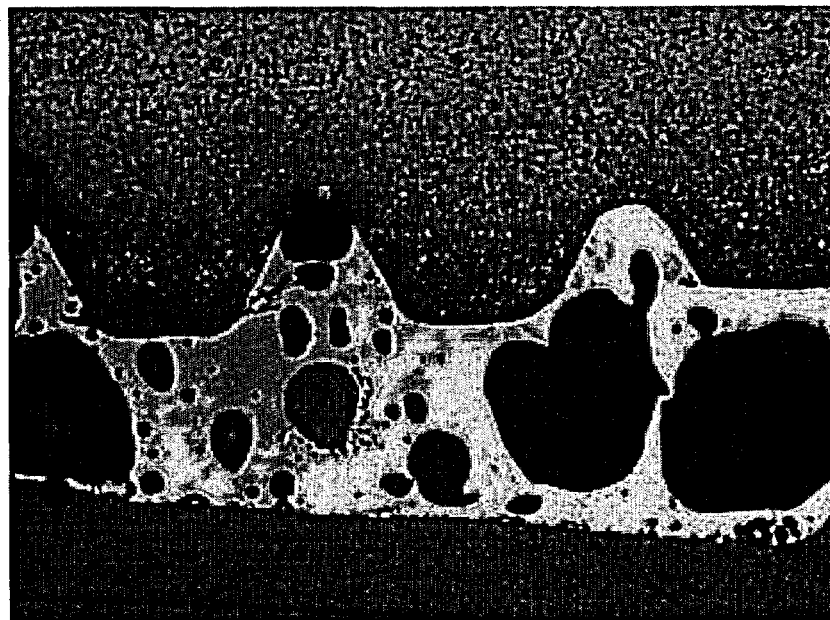
ImageNo:009A0240, Project No:A00064

A view of the cross-section of the beaded region in the threaded portion of the bolt is shown in figure 10, where the bolt is shown at the top of the figure and the beaded material appears lighter. Thread peaks in this area were missing. Numerous large voids were observed throughout the bead cross-section.

Figure 10. View of the cross-section of the intentionally-arc'd bolt in the threaded region. The bolt is shown at the top, and the porous copper region appears lighter. The dark areas in the copper region are voids.
